Colibri Scan Report

Licence Plate
188998 (2018)

Car Brand
TOYOTA

Car Model
TUNDRA

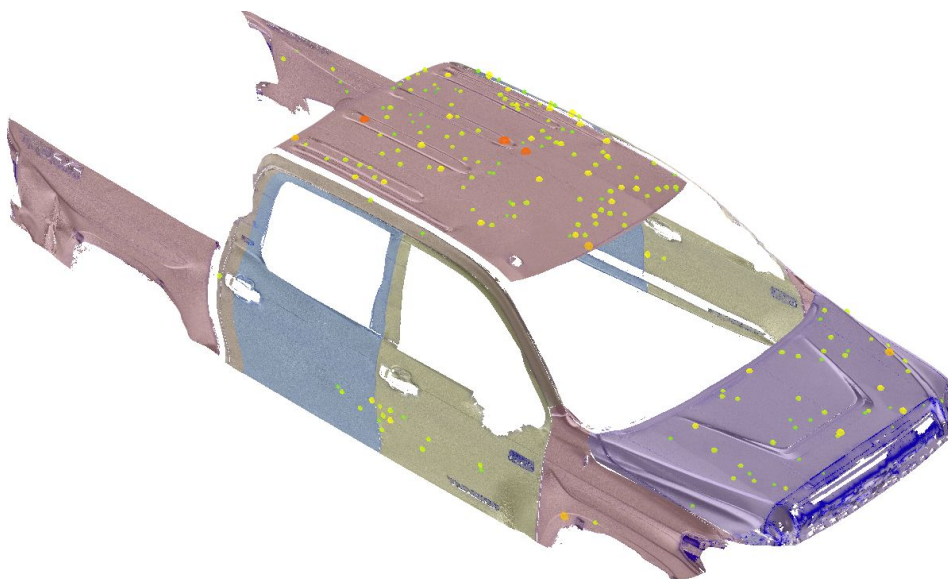
Left Fender 4 H	Hood 49 H 6 OS	Right Fender 2 H 1 OS		
Left Front Door 2 H 1 OS	Left Rail 11 H 3 OS	Roof 120 H 26 OS 1 DOS	Right Rail 3 H	Right Front Door 11 H 1 OS
Left Rear Door 4 H				Right Rear Door 4 H 1 OS
Left Quarter 7 H	Trunk No Dents	Right Quarter No Dents

Total Dents
All: 217

HalfDollar: 177

Oversize: 39

D-Oversize: 1

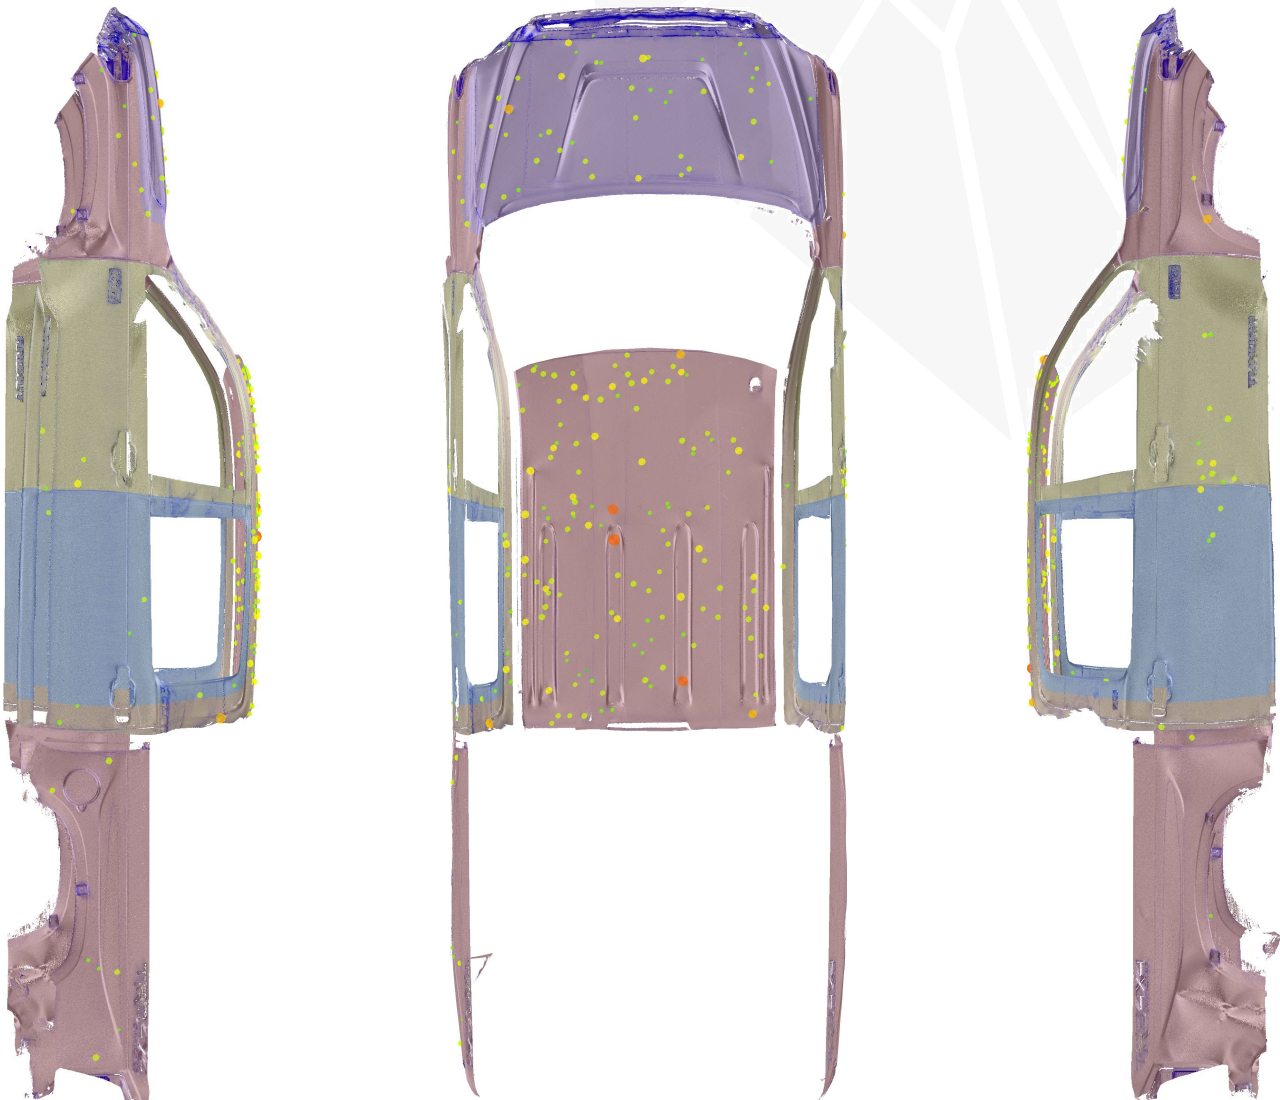
Panel	Type	Group	Oversize	D-Oversize	Total
Hood	HalfDollar	31-50	6		49
Right Fender	HalfDollar	1-5	1		2
Left Fender	HalfDollar	1-5			4
Roof	HalfDollar	101-150	26	1	120
Right Rail	HalfDollar	1-5			3
Left Rail	HalfDollar	6-15	3		11
Right Front Door	HalfDollar	6-15	1		11
Left Front Door	HalfDollar	1-5	1		2
Right Rear Door	HalfDollar	1-5	1		4
Left Rear Door	HalfDollar	1-5			4
Right Quarter	-	No Dents			
Left Quarter	HalfDollar	6-15			7
Trunk	-	No Dents
